SUBJECT: Page changes for the 4843 AMSF Closure Plan, Revision 1

# THE 4843 ALKALI METAL STORAGE FACILITY CLOSURE PLAN

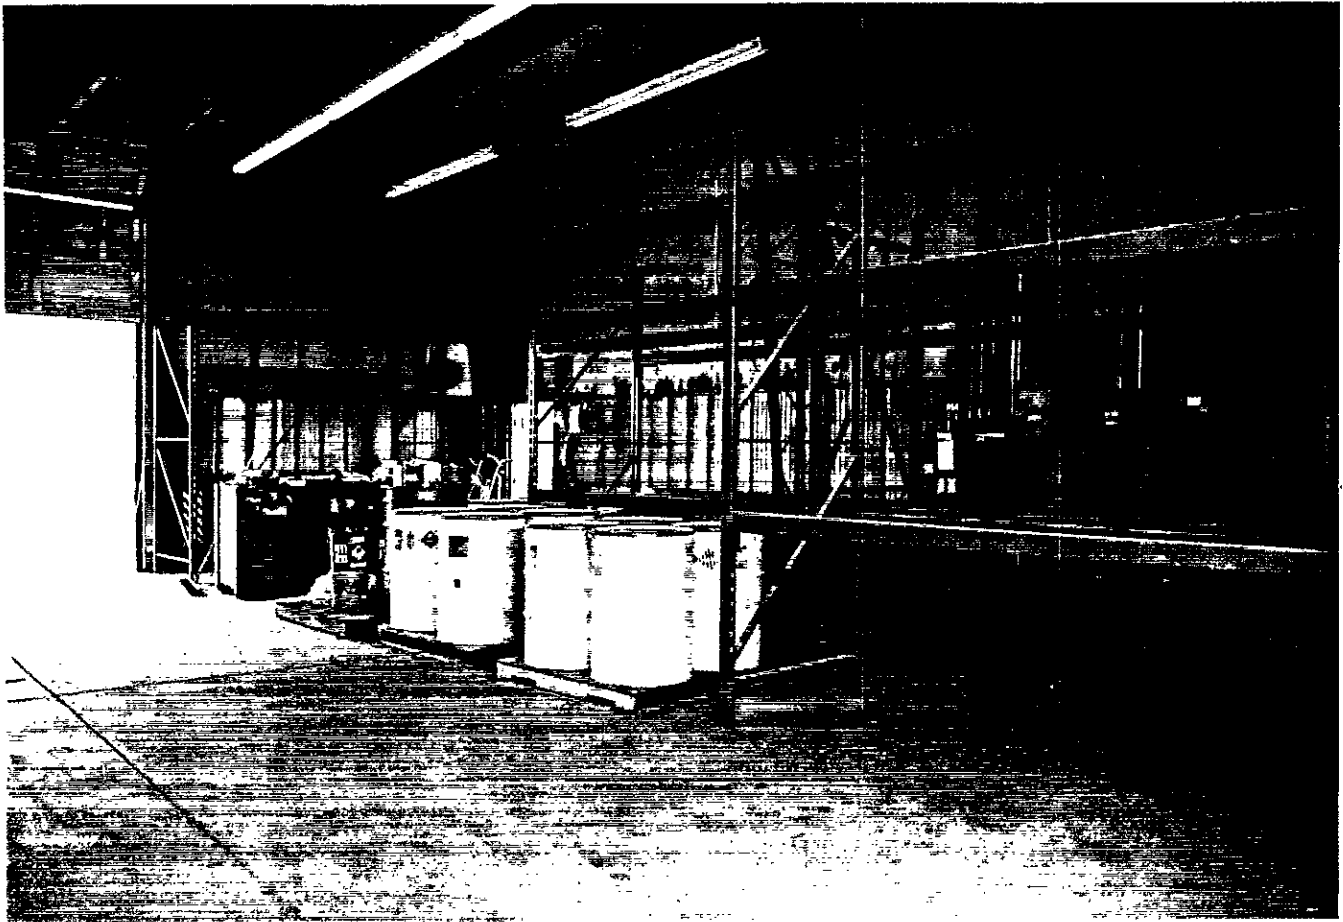
Figure E-3. Interior of the 4843 AMSF. Past configuration  
showing containers of dangerous waste.  
Photograph taken December 1990.

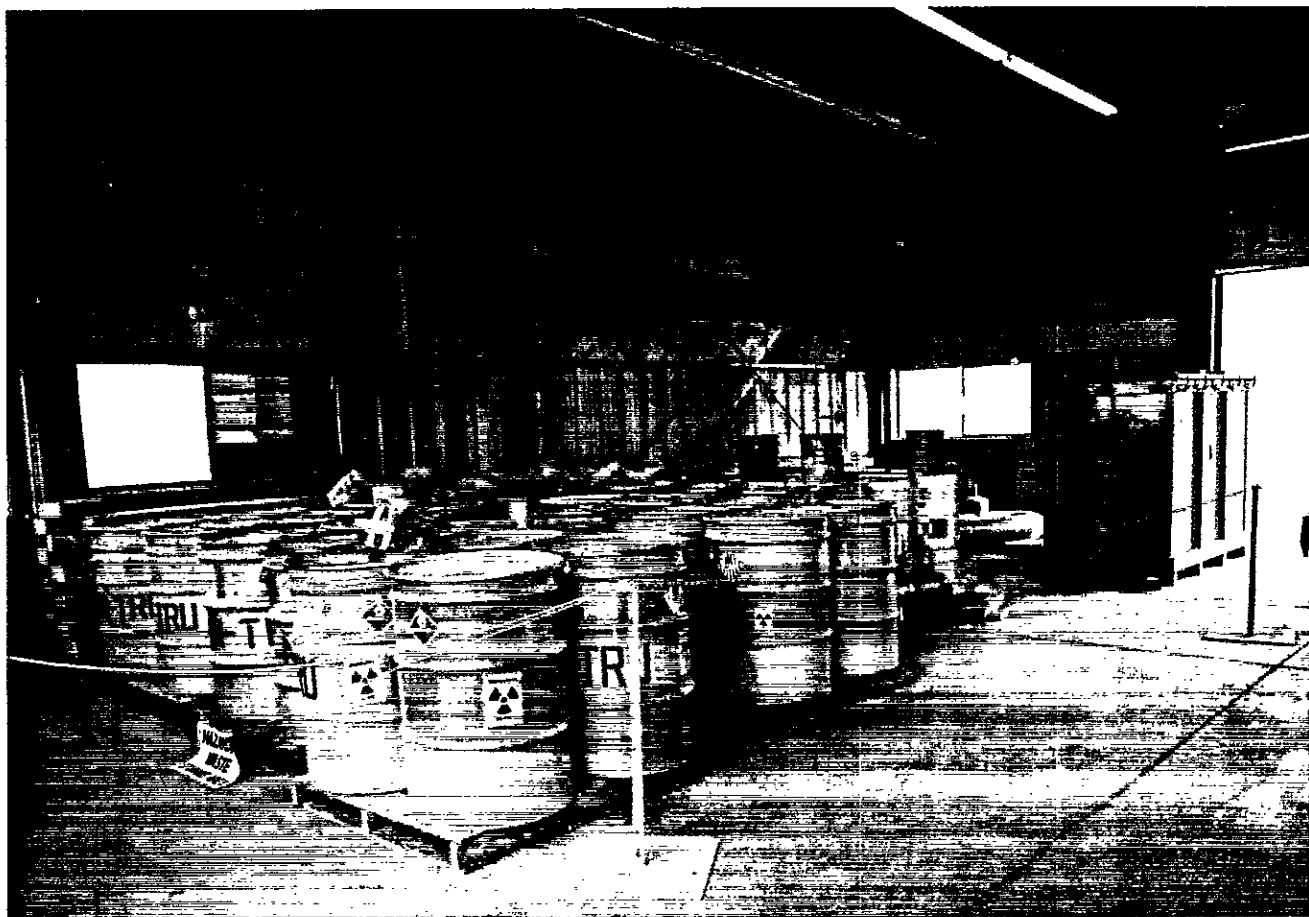
Figure E-4. Interior of the 4843 AMSF. Past configuration  
showing containers of mixed alkali metal waste.  
Photograph taken December 1990.
